# SUCCESSFUL REPAIR OF HURRICANE-DAMAGED WATER SUPPLY

- 250,000 residents without water
- 60' length of C301 PCCP installed underwater
- Rapid-response team averts water contamination

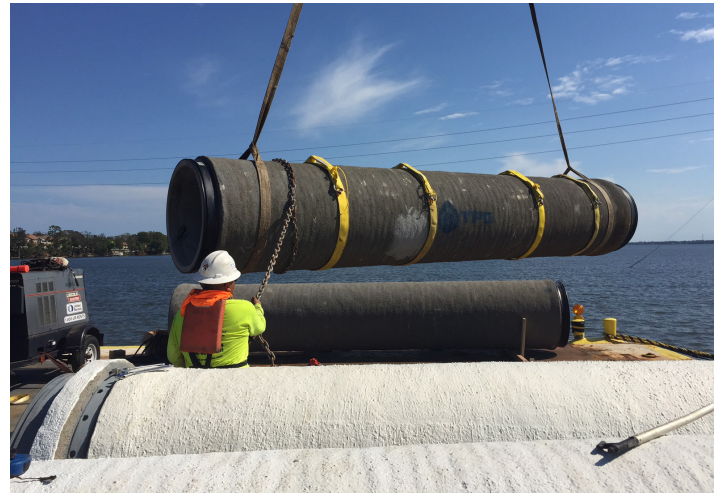
▲ 20-FOOT LENGTH OF PCCP IS LIFTED FROM THE BARGE

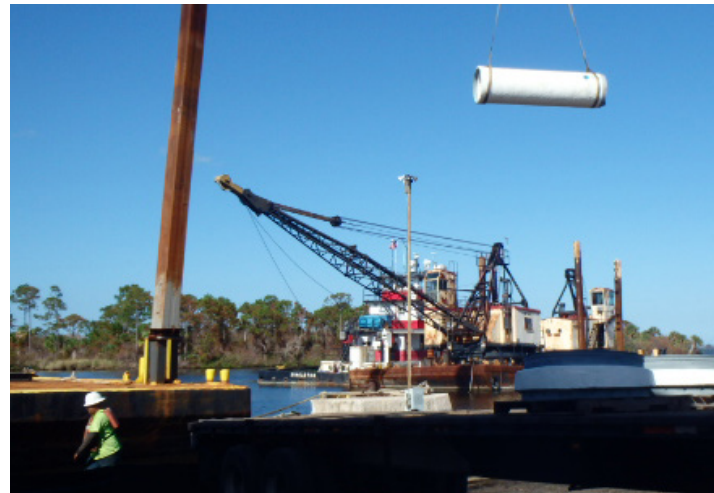
▲ SECTION OF 36" PCCP IS HOISTED INTO POSITION

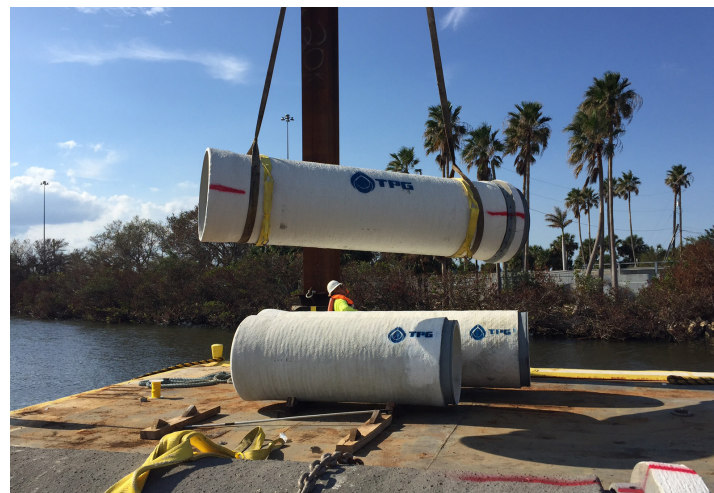
▲ BEVEL ADAPTER IS PRE-ASSEMBLED ON LENGTH OF PCCP
