## **Rehabilitation of Non-Round Sewers Utilizing Profile Shaped Fiberglass Pipe**

This paper will review a recent project installed in Los Angeles. The City of Los Angeles has utilized the slipline method of rehabilitation for their sewers for decades

This project was created to rehabilitate 1,795 feet of the West Los Angeles Interceptor Sewer (WLAIS) between the intersections of Venice Boulevard and Kelton Avenue and Venice Avenue and Overland Boulevard. The sewer was a 60-inch semi-elliptical pipe with a clay tile liner.

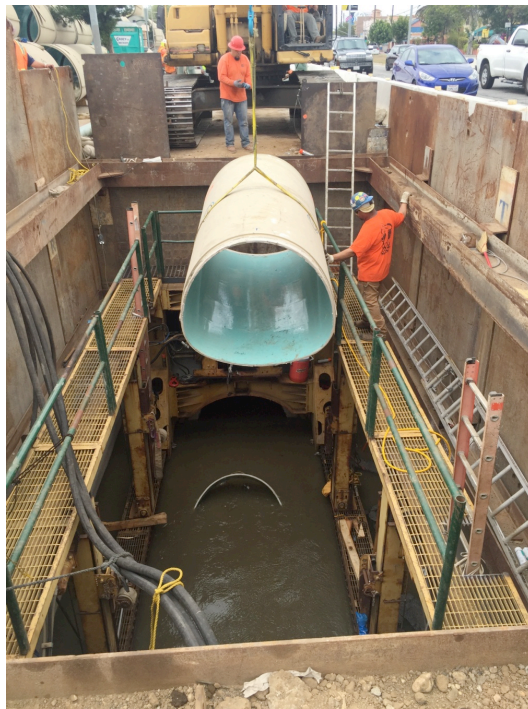
Installation of the FRP slipliner commenced in early September. Each pipe segment was transported by rubber tired construction equipment from the pipe storage area to the pit location which was approximately 1 to 2 miles away. The installation of the slipliner was able to be conducted during live flow condition. It took Colich and Sons less than 30 minutes to install a single segment of the slipliner pipe.

**Figure 8: Installation of Non-Round FRP Slipline Segment**

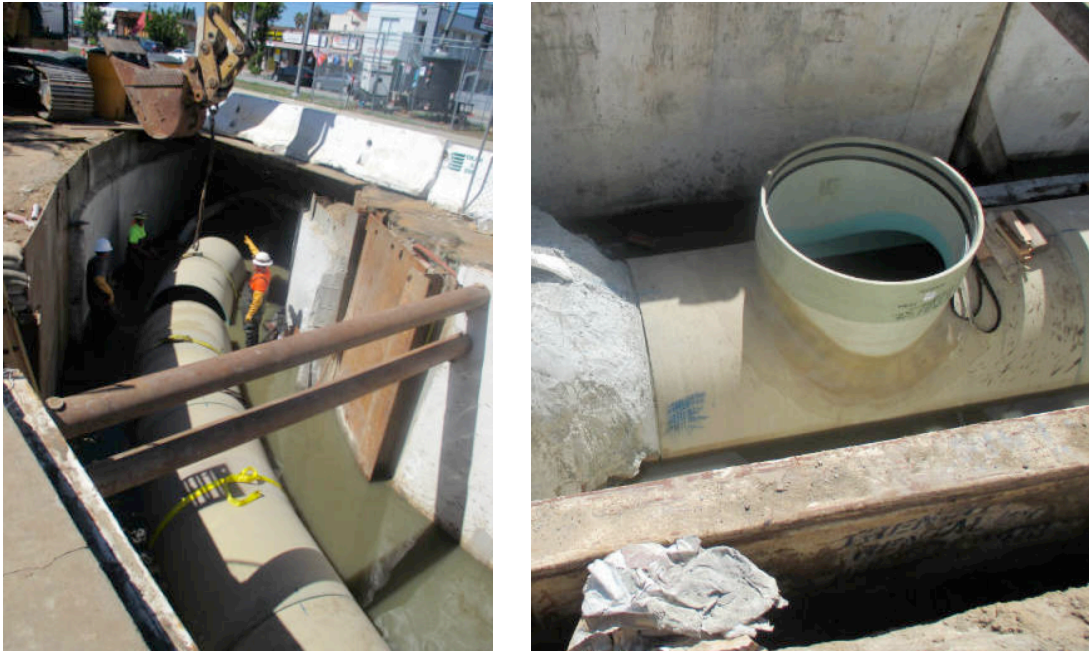
One of the biggest challenges was the curve section on the project. In order to install these sections on the project, the curve sections were excavated and each segment was placed individually. The slipline pipe manufacturer created bends using mitered sections of the pipe to fit the curved alignment. Manholes were also included in these sections which were manufactured by the pipe manufacturer using the non-round slipline pipe material.

**Figure 9: Installation Non-Round FRP Slipline Bend Segments and Manhole**
