TODAY'S PCCP SPARKS NEW LIFE UNDER POWER LINES

Old Interpace pipe replaced with new superior prestressed concrete cylinder pipe

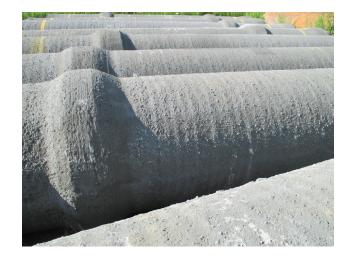
In several areas roadways and power lines prevented open cut trenches. The project included 3,100 linear feet of Thompson Pipe Group 36" PCCP. Additionally, five bores required 60" steel casing. Thompson Pipe Group manufactures trenchless PCCP with raised mortar coated skids which eliminate supplemental casing spacer failures.

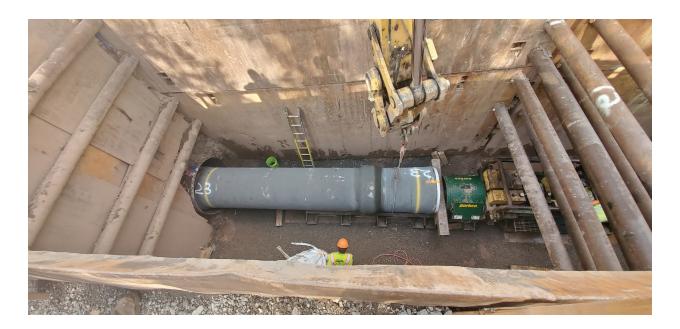
The Thompson Pipe Group PCCP rubber and steel gasketed joint rings provide a positive leak-free seal. This project incorporated testable joints which allow the contractor to receive immediate feedback on the integrity of the joints. This ensures a leak-free hydrostatic test.

Harness clamp joints provided restraint where necessary. The two-part harness clamp is positioned around the joint and secured simply by tightening drawbolts on each side of the pipe. Joints are covered in thick cement-rich mortar coating. No welding or cathodic protection required.
