## **CASE STUDY - MIAMI DADE EMERGENCY SLIPLINING REHABILITATION PROJECT**

Emergency Rehabilitation of a 72-Inch Raw Water Main  
Preston Water Treatment Plant – Miami-Dade County,  
Florida, Serving approximately 2.8 million residents

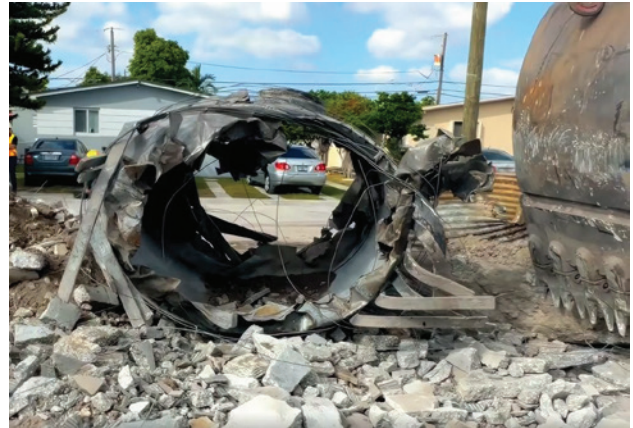
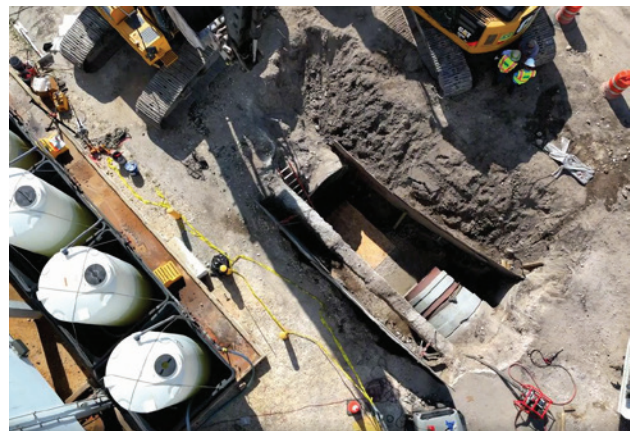
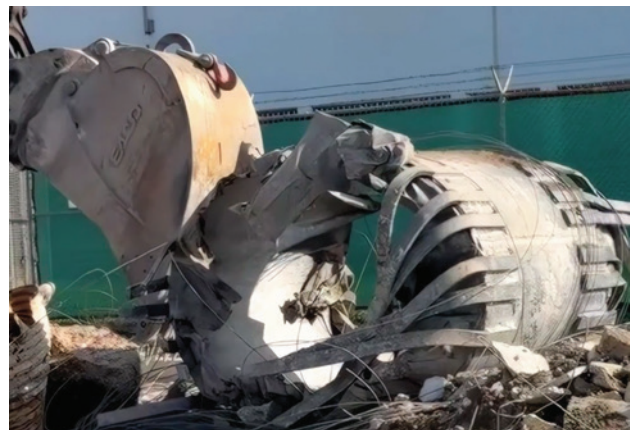
Condition assessments identified increasing wire breaks and corrosion of steel bands along a 400-foot segment of the 72-inch PCCP. The pipeline had previously undergone multiple localized repairs, including carbon fiber reinforcement, and was under continuous fiber-optic monitoring. These findings raised concern that continued deterioration could lead to a sudden failure, resulting in major service disruption and emergency response impacts.

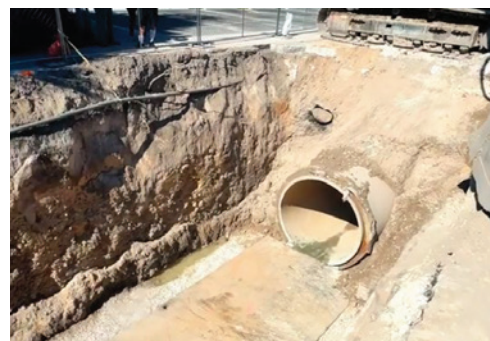
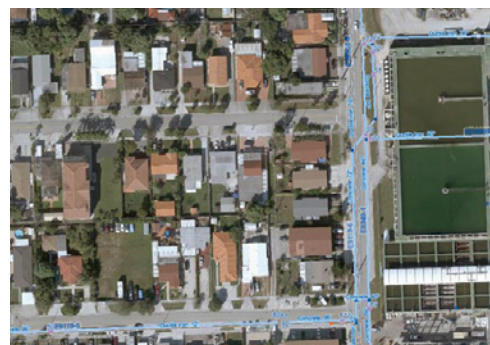
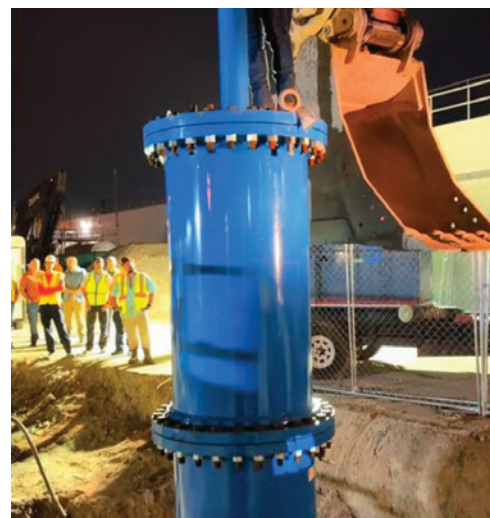
A minimum of two (2) access manholes were installed to provide internal access to the rehabilitated pipeline section.

These manholes facilitated liner installation, inspection, termination work, and future maintenance activities in accordance with MDWASD requirements.

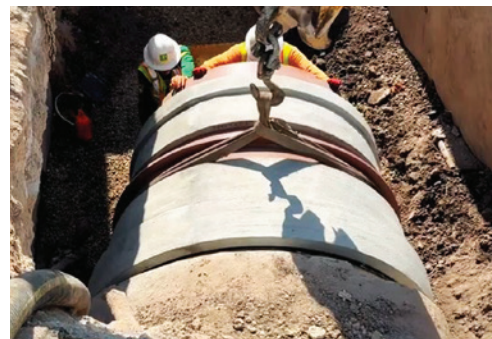
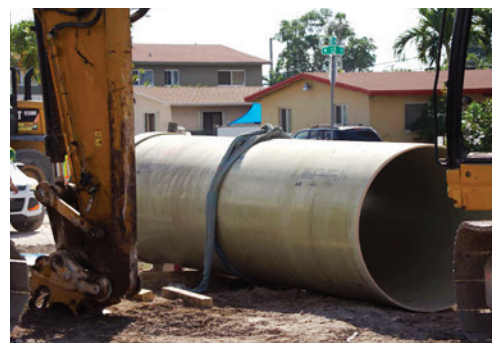
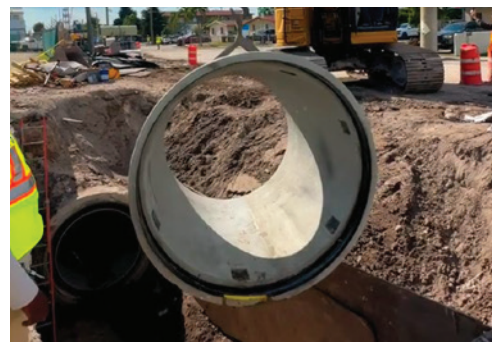
Following engineering evaluation, TPG performed thrust force calculations based on operating pressure (10–15 psi) and bend geometry. Analysis demonstrated that the cementitious grout used to fill the annular space between the FRP liner and host PCCP provided sufficient axial resistance to counteract thrust forces generated at the elbows.

The grout confinement, combined with the host pipe geometry and frictional resistance, provided adequate restraint without requiring additional mechanical locking systems. This approach simplified installation while maintaining structural integrity and long-term performance.

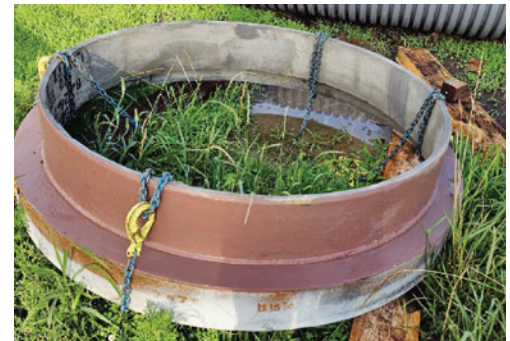
At both the upstream and downstream ends of the rehabilitation segment, TPG proposed and supplied custom-fabricated steel adapter assemblies. These adapters were designed not only to transition between PCCP and FRP materials, but also to function as reducers accommodating the change from the 72-inch host pipe to the 60-inch liner system. The assemblies were engineered with PCCP-compatible weld interfaces, FRP termination geometry, and clearly defined axial load paths to ensure structural continuity and long-term durability. Additional fabrication and detailing information can be provided by Jim Fisher regarding these specialized components.
